The Summerhouse at Homme House

the restoration of a folly

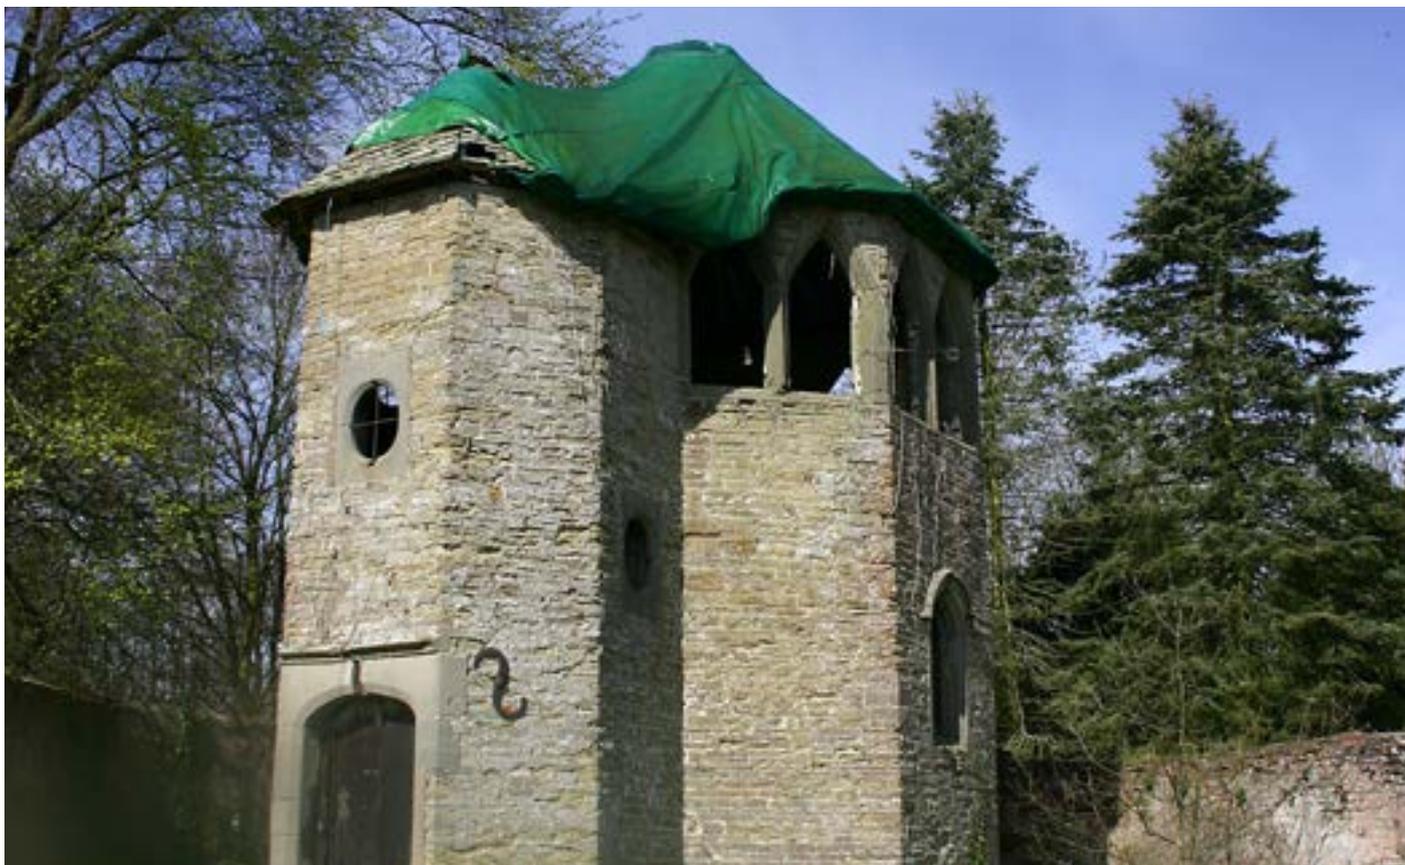
The Summerhouse, early 20th century

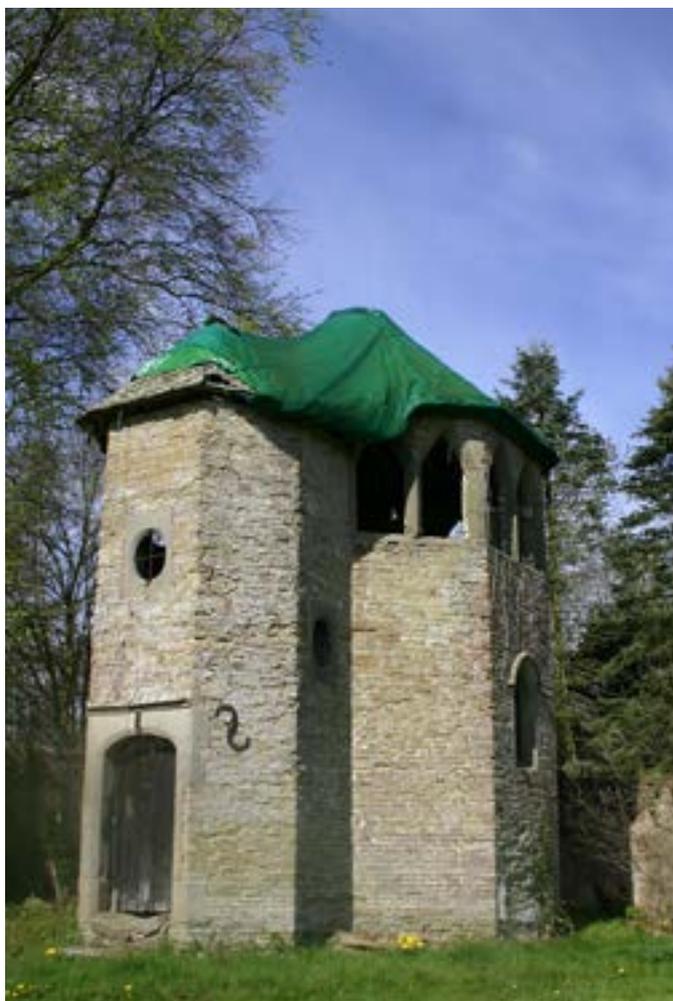
After careful consideration and examination of the photographic evidence, it was agreed to restore the lantern to the roof but to leave the roof construction exposed internally, albeit with a lath and plaster ceiling between the hip rafters for practicality of use of the upper room. Repairs to the roof structure and the new lantern were completed using English Oak and all stone repair and piecings, including new sections of the chimney shaft, were carried out using Forest of Dean stone to match the original.

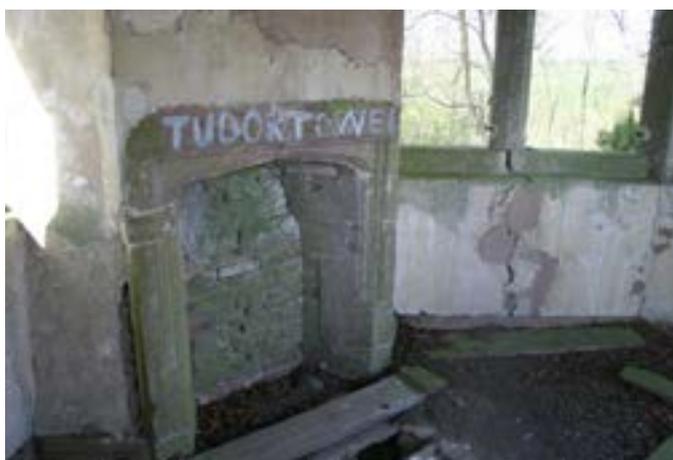
vii. Minor repairs: 'JOS' stone cleaning was used successfully to remove graffiti inside and the ancient, but not original, entrance door was carefully conserved with the addition of thin slivers of oak and a new security lock with concealing oak lock box.

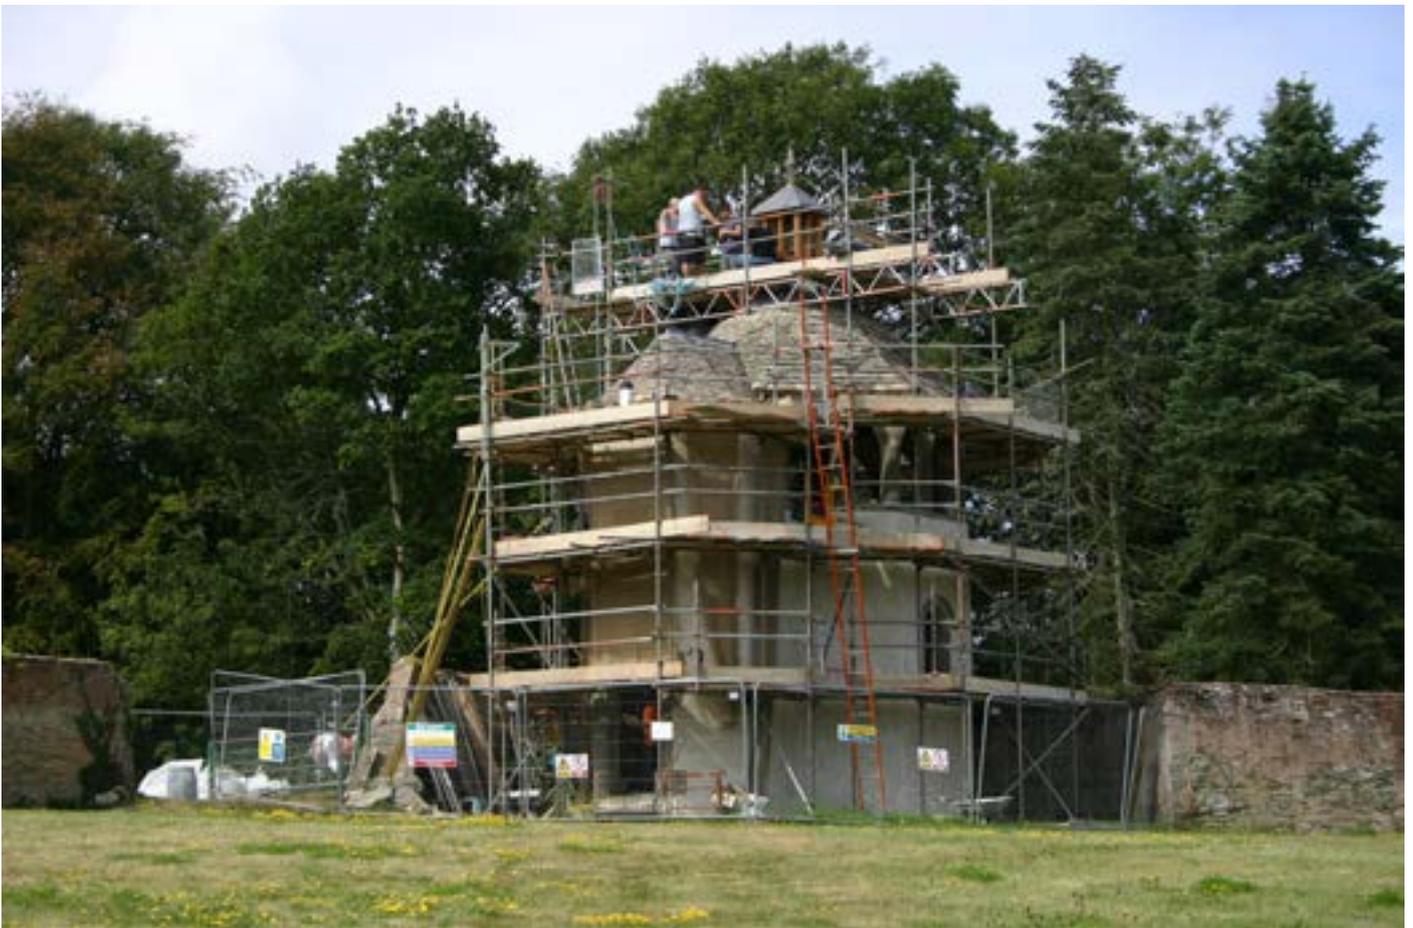
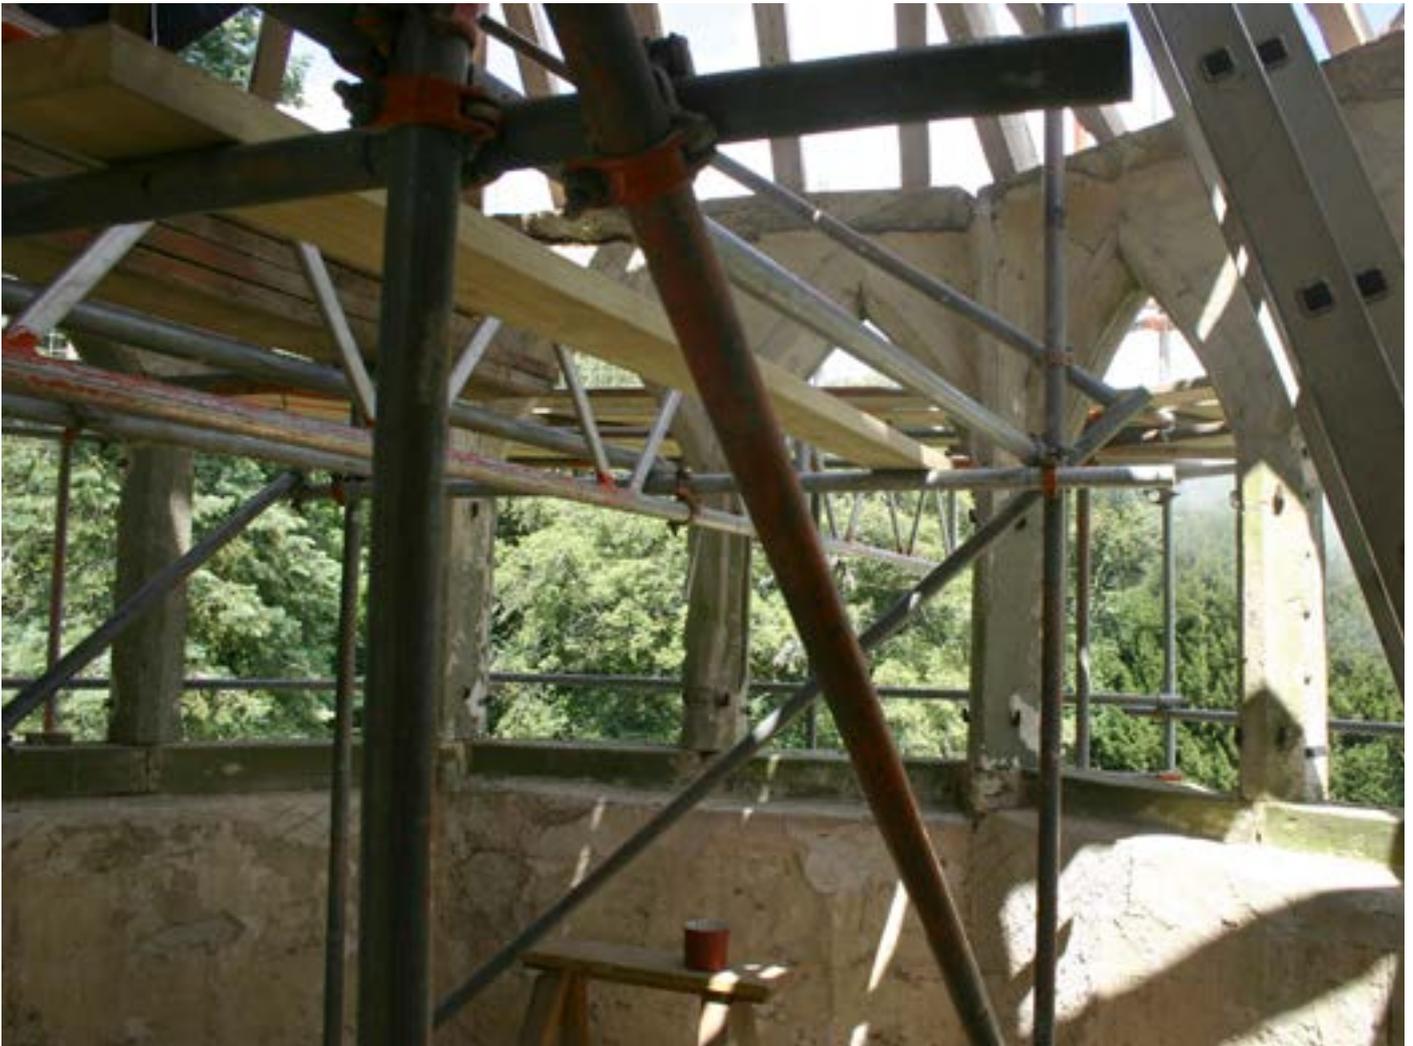
hung, metal casements, were a later modification. The structure was unstable because it had never been fitted with rainwater goods so storm water fell directly onto the ground from the roof slopes causing the walls to 'overturn' at the outer edges of their bases. Furthermore, the configuration of the eight faceted roof is unrestrained so created an outward thrust to the walls at their heads. Finally, roof leaks caused the first floor 'diaphragm' to decay, become structurally unsound and cease to provide lateral restraint to the walls at mid height. Inevitably, therefore, the walls buckled and cracked vertically as they overturned and were 'pushed' by the roof structure and its heavy loading of tiles. All this presented a unique challenge for the restoration process.

The Summerhouse prior to restoration, 2011

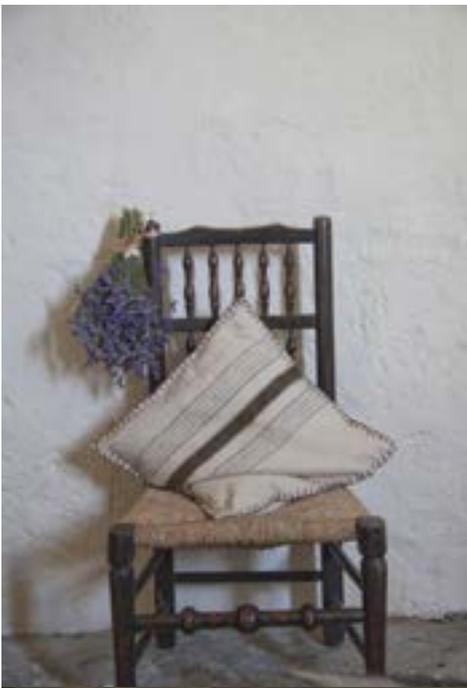
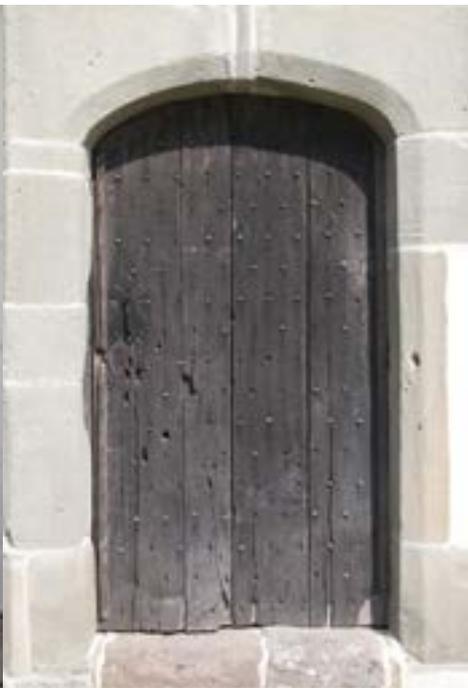
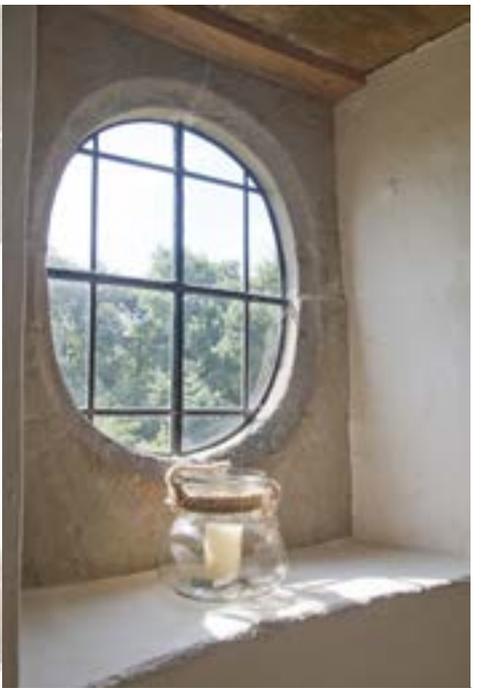
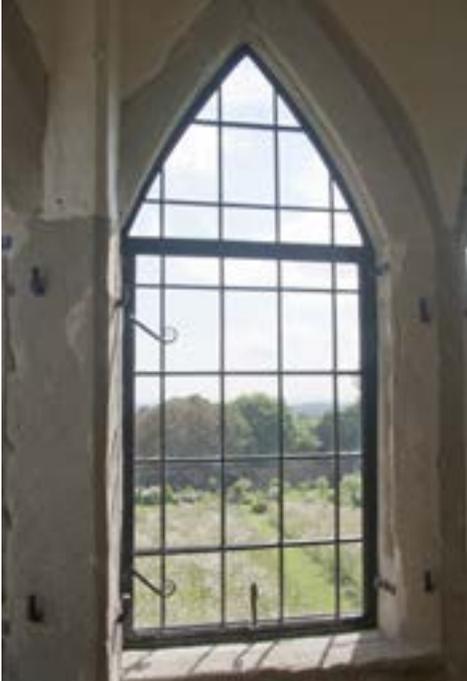
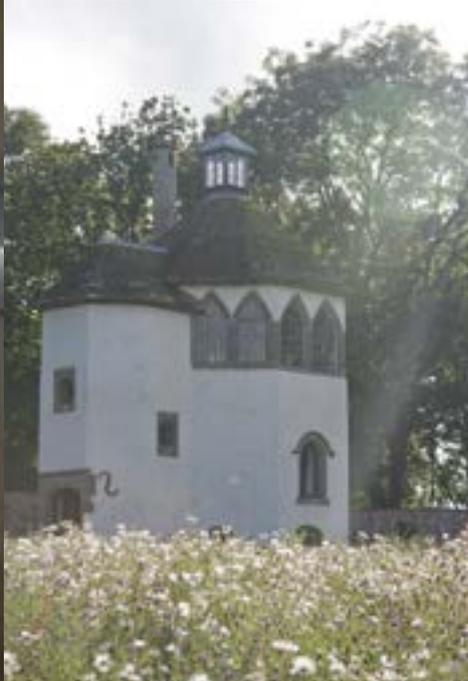
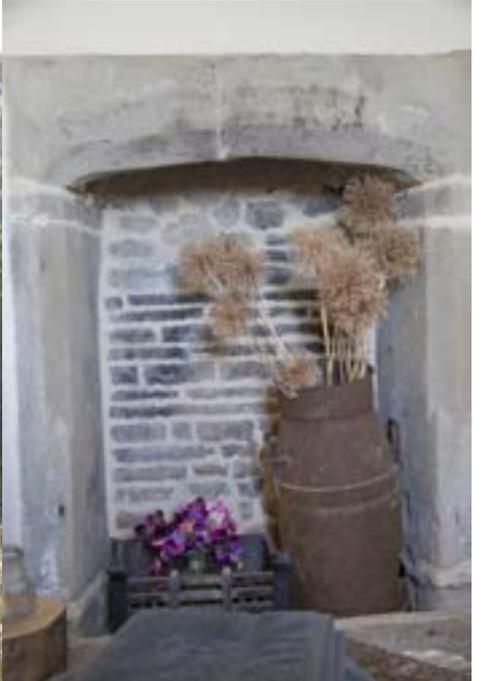
The Summerhouse undergoing restoration, summer 2011

- i. Removal of roof tiles & underpinning: the heavy stone tiles were removed using a cherry picker and limited sections of underpinning carried out to stabilise the incredibly fragile structure in preparation for further work.

- ii. Structural bracing: a scaffolding 'corset' was constructed around the exterior of the Summerhouse in order to hold it together in the early stages of the works.

- iii. Stabilisation of walls: it was agreed that no attempt should be made to pull the Summerhouse back into its original verticality but to stabilise the walls, as found, cracks and all. The cracks were stabilised using 'Cintec' anchors and stainless steel 'Helities' before being filled with stone slips and tiles.

- iv. Rendering & repair to plaster work: the outside of the building was re-rendered using an NHL2 hydraulic lime/sand mix, designed by taking and analysing samples of the surviving external render and using locally sourced aggregates to provide the same colour, texture and "gritty" mix of the original. The surviving original render was consolidated in-situ. The internal plaster of the walls, much of which was original, was repaired.

vi. Installation of 'French' drain: to prevent the same structural problems from arising again, the roof overhang was extended throughout by approximately 75 mm to throw water further away from the walls and their render coating, and a 'French' drain was installed around the entire perimeter of the Summerhouse to discharge storm water away from it.

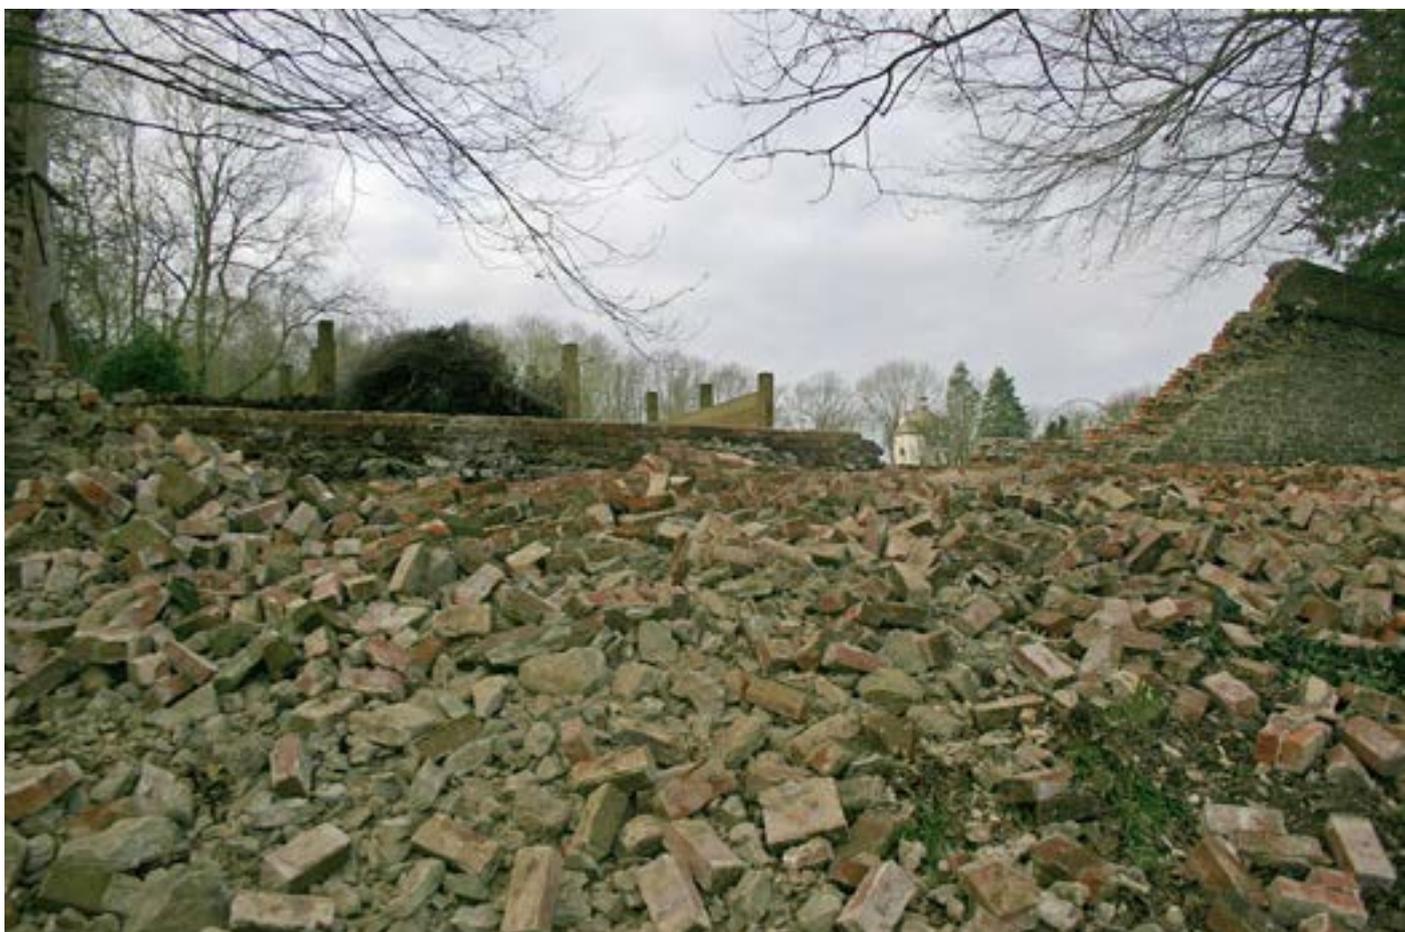
Storm damage, January 2012

2012 presented us with a temporary setback, when in a January gale a large section of the west-facing wall was blown down, and bricks scattered as far as the lawn - a real blow as this was the only wall in the whole garden which wasn't in desperate need of repair! The wall was luckily swiftly restored in time for the start of our wedding season, and work then continued to restore the other walls of the Walled Garden, a long and ongoing process. Neil Duggan is a local craftsman who specialises in the use of the lime mortar required to do this work, a painstakingly slow process given its restriction to warmer, frost-free months.
